ERBIL MATERNITY AND PEDIATRIC
HOSPITAL
ERBIL, IRAQ

SUSTAINMENT ASSESSMENT

SIGIR PA-06-094
APRIL 19, 2007

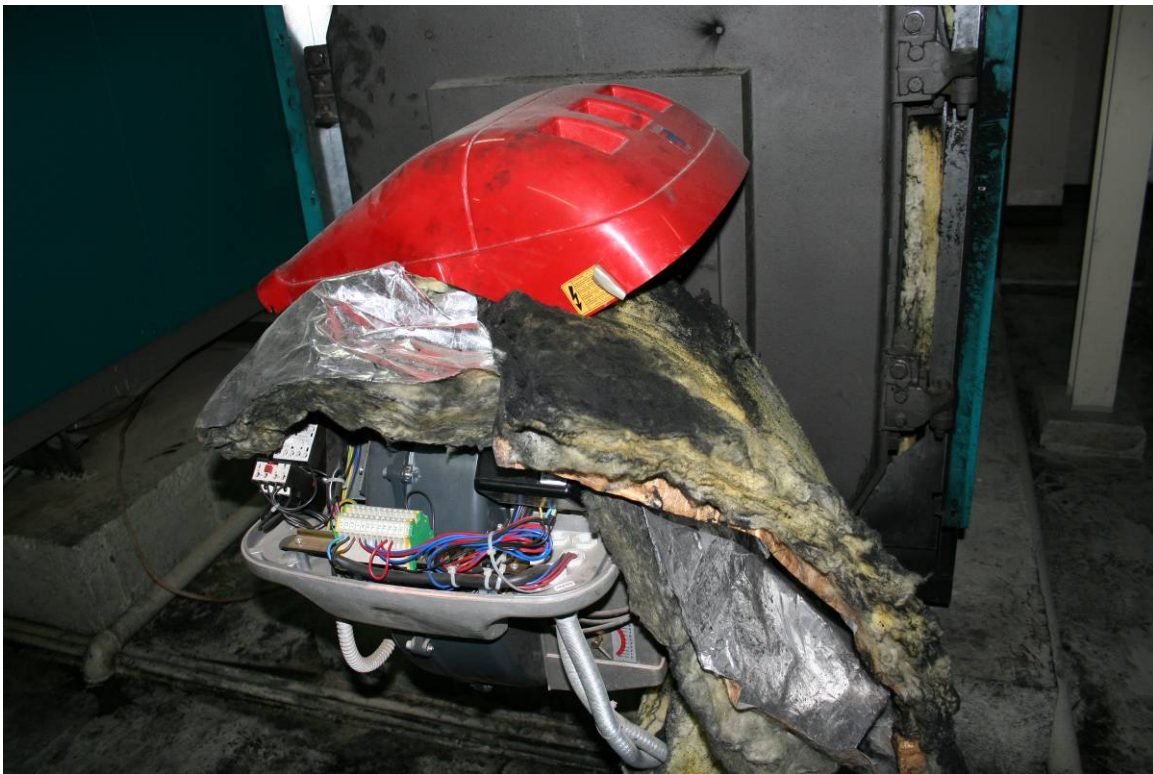
Although all boilers were operational when commissioned and turned over, one of the boilers was inoperable when SIGIR inspectors visited the site. Hospital personnel told the inspectors that the boiler malfunctioned and has since been used as a parts source to maintain the other boilers. In Site Photo 28 the middle boiler has the cover removed and is coated with a carbon film, possibly caused by a fire. Only one boiler was operating at the time of the SIGIR site visit.

Site Photo 28. One of the three boilers was cannibalized for parts.

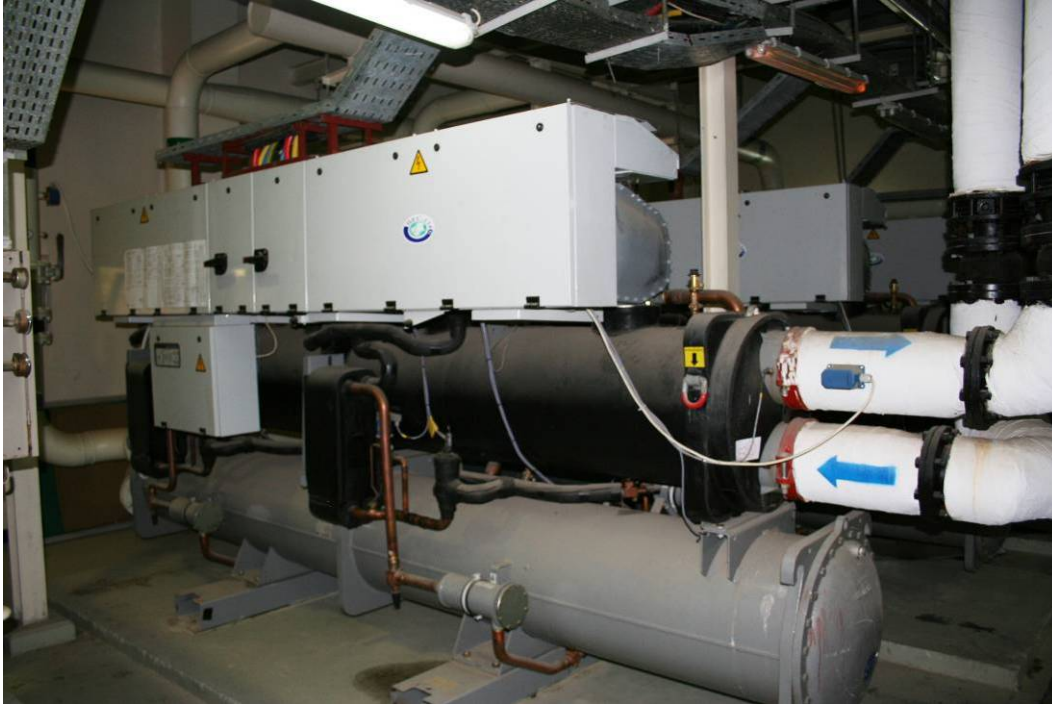
Inspectors observed three new chiller compressor systems installed in the mechanical room. One of the chiller compressors is shown in Site Photo 29. Although cold weather prevented inspectors from observing chiller operations, the RE stated that the chillers were operational when commissioned and turned over 1 May 2006 and hospital personnel told the inspectors that the cooling system was operational.

Site Photo 29. Chiller installation appeared satisfactory.

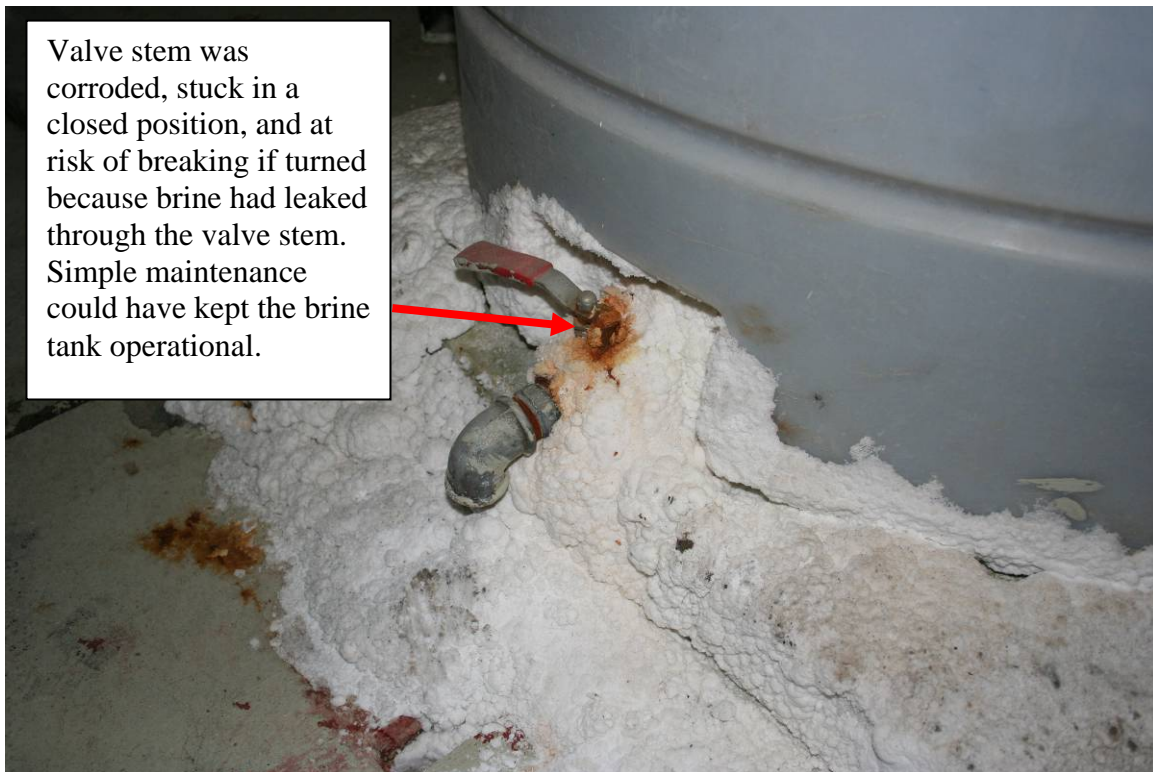
At the time of inspection, the water softener system appeared not to have been operating for an extended period of time. The tanks contained thick discolored brine that had a pungent odor. Inspectors observed a buildup of salt around the brine tank drain valve. Site Photo 30 shows dried brine around a tank. The salt encircled the base of the tank and encased the drain pipes in a thick mass of salt. Corrosion (rust) coated the valve stem and the tank's drain valve. Oxidation, due to the salt, deteriorated the valve to the degree that serviceability appeared questionable at the time of inspection. If turned, it appeared that the valve's stem could have broken off.

The buildup at the base of the tank appeared thick and formed a solid structure. This suggested a low water flow (a leak) over a considerable time. The salt formation suggested water evaporation as the primary reason for the buildup. Additionally, the volume of salt in the relatively small surface area suggests that a large amount of salt and water had leaked and dried.

The RE and inspectors agreed that more than likely ineffective maintenance practices caused the breakdown of the water softener system. The RE also agreed that water softener operations and maintenance is not complex when compared to the heating and cooling system as a whole. However, the lack of a functioning water softener system could lead to future large-scale problems in the heating and cooling system.

Site Photo 30. Dried salt was layered around the base of the brine tank.

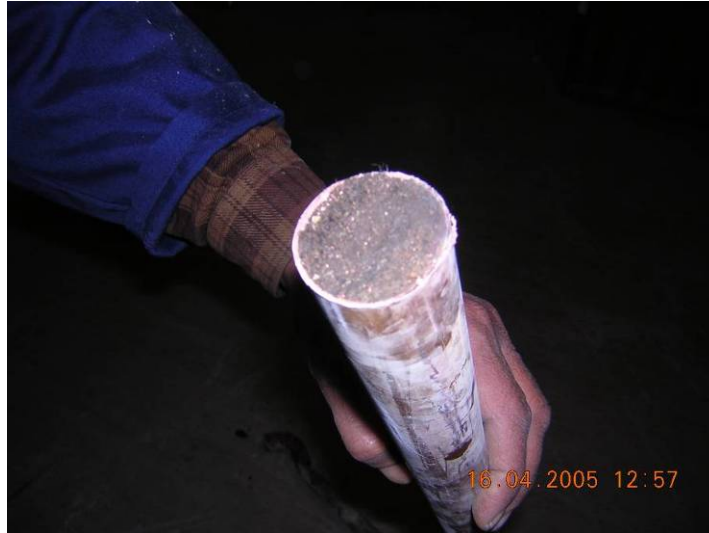
SIGIR found evidence of past maintenance problems with the HVAC system at the facility prior to the U.S. funded reconstruction project. Specifically, particles clogged the HVAC system before construction. A clog made up of settled particles that closed off a chiller water line is shown in Site Photo 31.

Site Photo 31. Plugged chiller water line before renovation. (USACE photo)

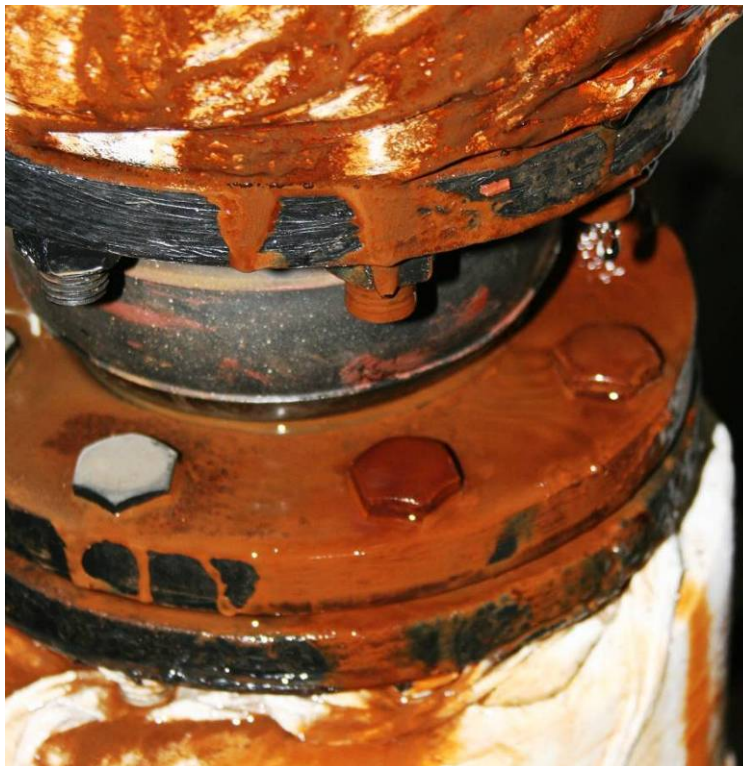
A flushed system with clean filters could prevent future failures, overheating and boiler cracking caused by plugging, and deterioration of materials. Inspectors observed rust and a water leak in piping above the hot water pump. In Site Photo 32, a water leak developed layers of rust across the surface of hot water piping. The rusty water from the leak indicates a very strong likelihood of a rust and particulate buildup forming inside the new piping. Considering the hospital's history of the clogged HVAC pipe pre-renovation and other maintenance practices, it is likely that without a positive change in operations and maintenance practices, degradation of the HVAC will result.

Site Photo 32. Evidence that rust contaminated water has leaked from a hot water line flange for an extended period of time.

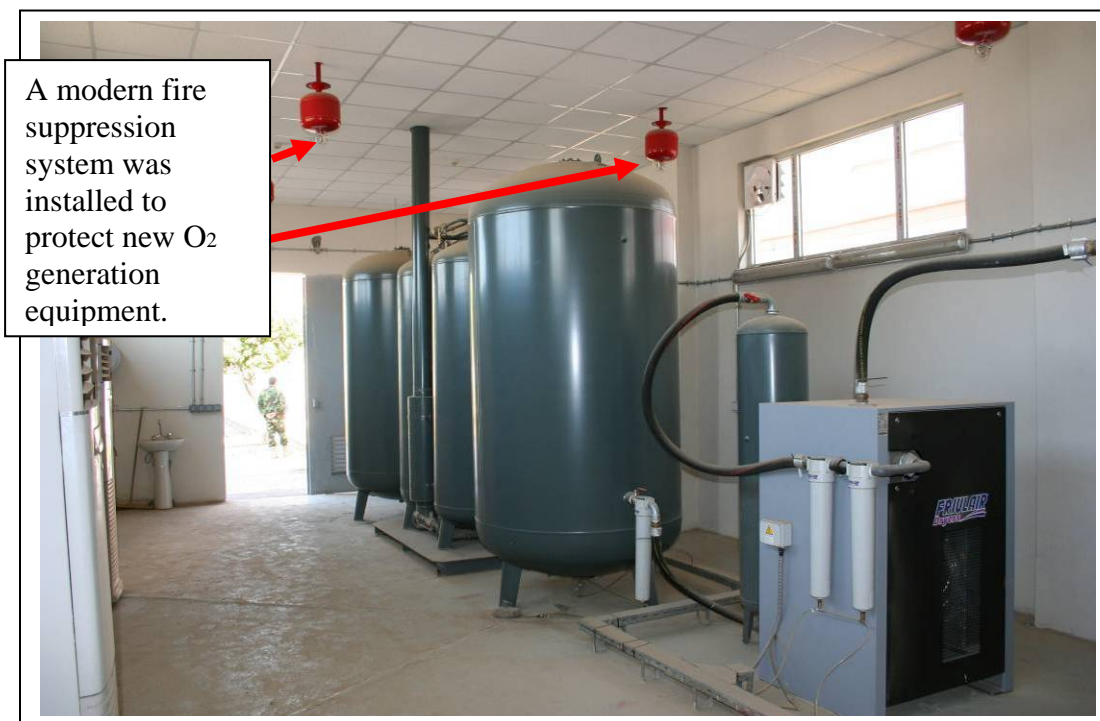
SOW requirements included an updated oxygen and delivery system. The new generation system was operational at the time of the site visit (Site Photo 33). To meet hospital needs, the design was comprised of an oxygen generator capable of producing 94.5% pure oxygen at a rate of 800 liters/minute at 4.09 - 4.49 bars of pressure, an oxygen tank capable of holding 3000 liters, an air compressor, refrigerated air dryer, and an air filtration line. In addition, the contractor installed a centralized system of piping and controls to deliver oxygen to patient care rooms. As a backup to the new system, the contractor's design included retaining the original system. However, the inspectors were told by hospital workers that "they mistrusted the new system." As a result, the inspectors observed that the original oxygen system was used as the primary source of oxygen to patients while the new system was used as a backup.

A modern fire suppression system was installed to protect new O₂ generation equipment.

Site Photo 33. Renovation included an O₂ generation system.

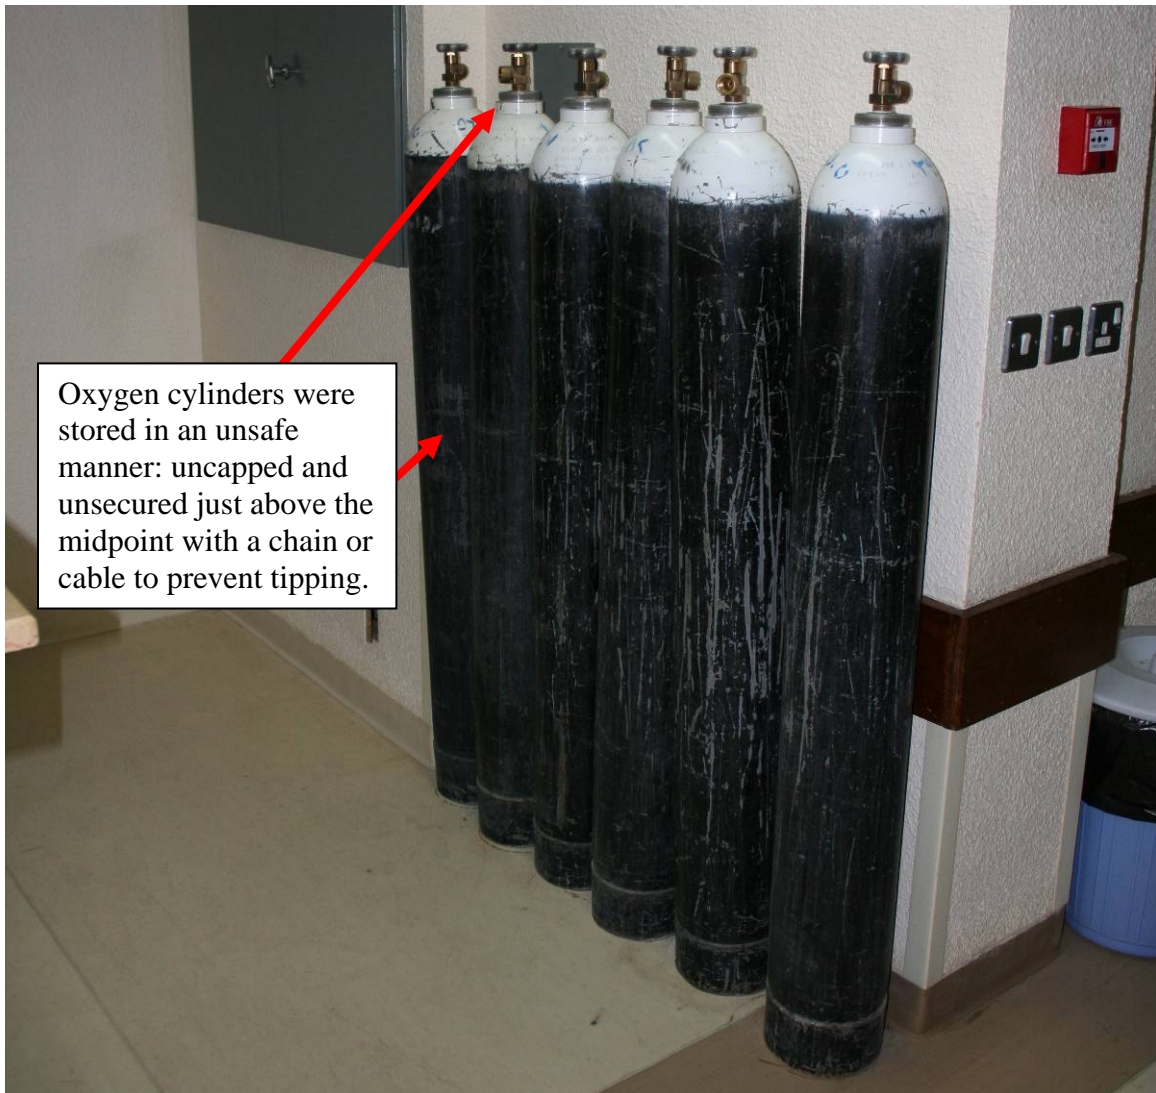
The inspectors also observed that the cylinders were stored in an unsafe manner. Specifically, valves were not protected with a cap, a chain or cable placed just above the midpoint was not used to secure cylinders in an upright position, and the cylinders were not stored in a protected area away from hallway traffic.

Site Photo 34. O2 bottles were stored in the hallway.

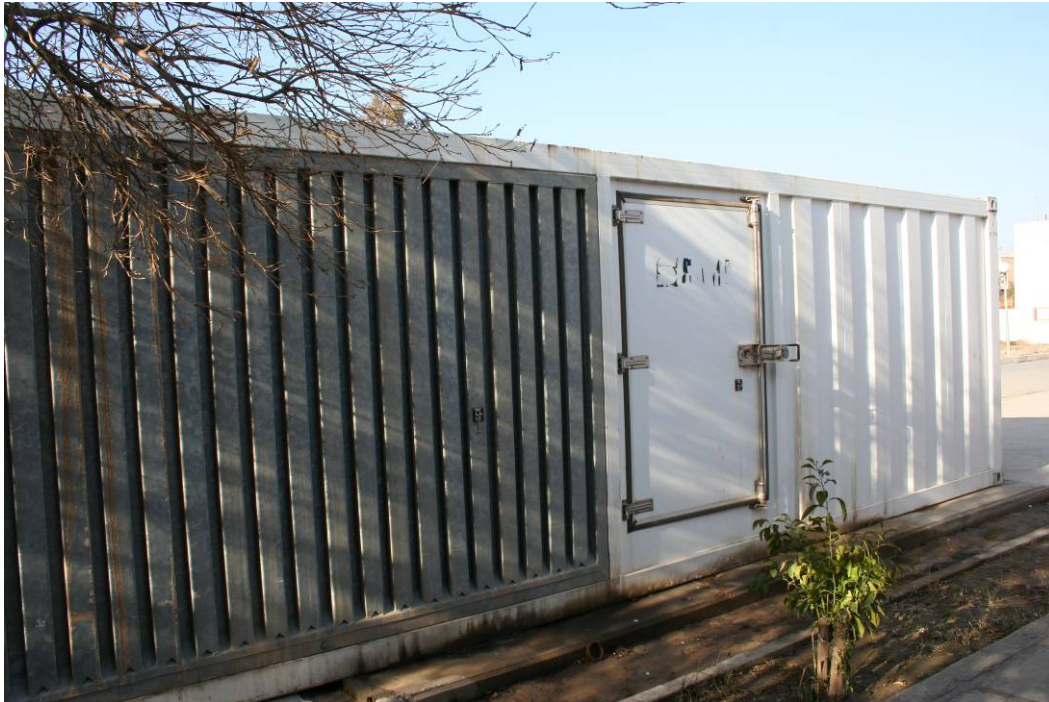
Site Photo 35. Generator installed pre-rehabilitation by World Health Organization.

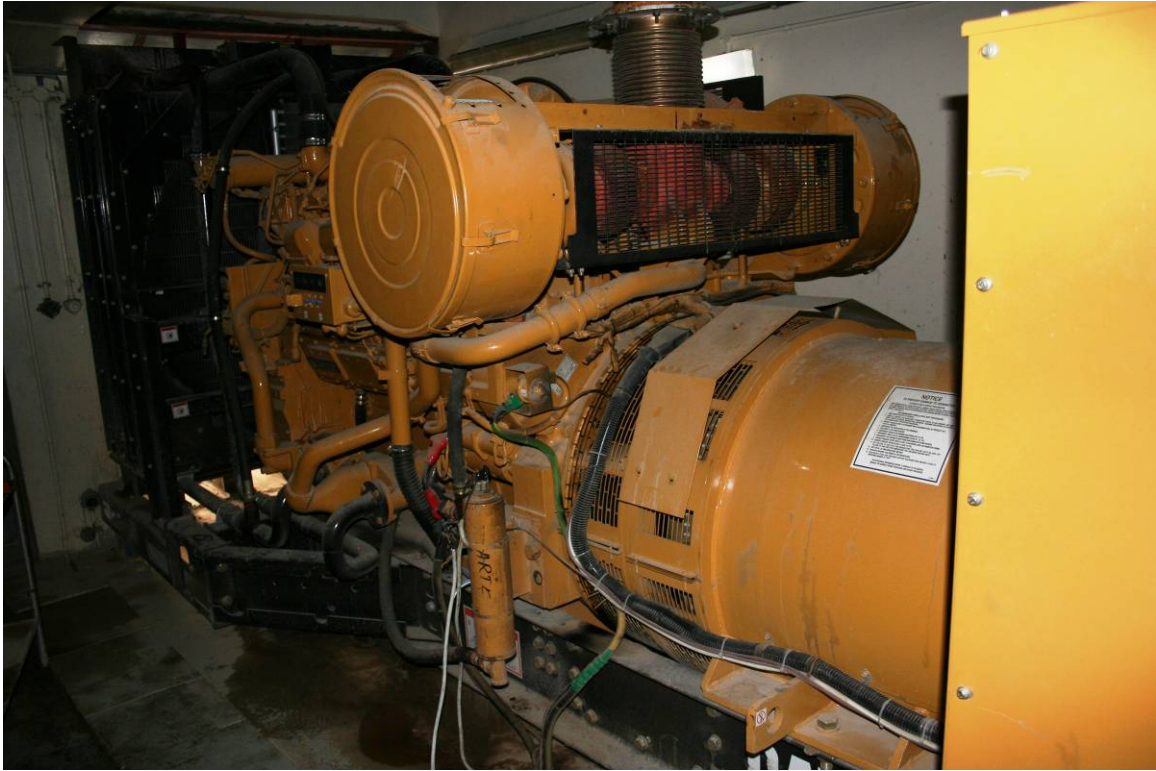
In compliance with SOW requirements, the contractor installed a new 800 kW 1000 kVA generator. Site Photo 36 shows the new generator installation. The RE stated that the new generator was designated to act as the first back-up. In addition, documentation retained in USACE project files indicated that the “tie-in” of all generators was properly completed before being turned over to Iraqi officials. As required by the SOW, the new generator significantly increased overall electrical capacity. While on site, SIGIR inspectors observed the generator system operating.

Site Photo 36: New generator was used as a back-up.

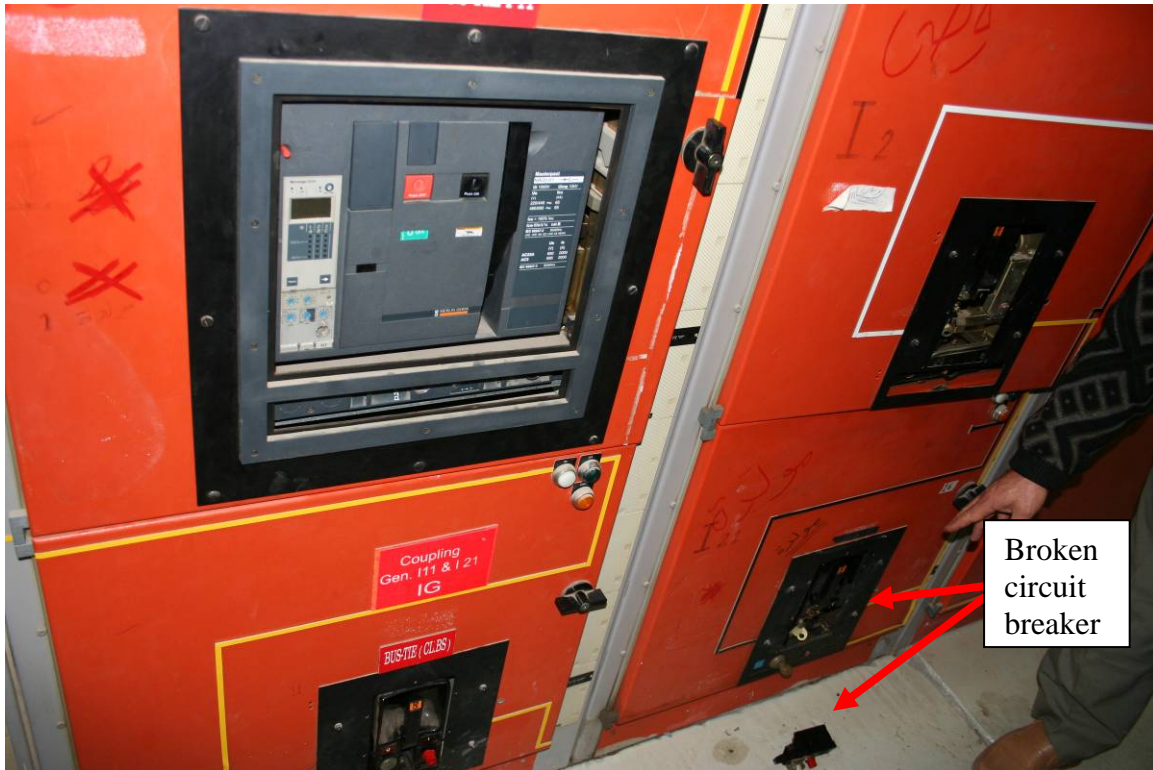
Switchgears link the power system and generators. Site Photo 37 shows a broken breaker that prevents the switchgear from automatically operating as designed. In the photo, a piece of the broken switchgear lays on the floor while the circuit remained in the open or off position. Although hospital personnel pointed out the broken breaker to inspectors and the switchgears remained under warranty, hospital maintenance workers told SIGIR inspectors and the RE that they had not initiated any efforts to secure repair or replacement via the manufacturer.

Site Photo 37. Broken circuit breaker that disabled switch gear equipment.
